**AN UPDATED TECHNICAL REPORT ON
THE PIMENTON MINE AND ITS TAILINGS POND GOLD POTENTIAL
REGION 5, CHILE
FOR
MINERA TIL TIL SpA,
A WHOLLY OWNED SUBSIDIARY OF
CERRO GRANDE MINING CORPORATION**

Prepared by

ROMÁN E. FLORES VILLALOBOS, Senior Geologist, Qualified Person # 186, CHILE

April 19, 2022

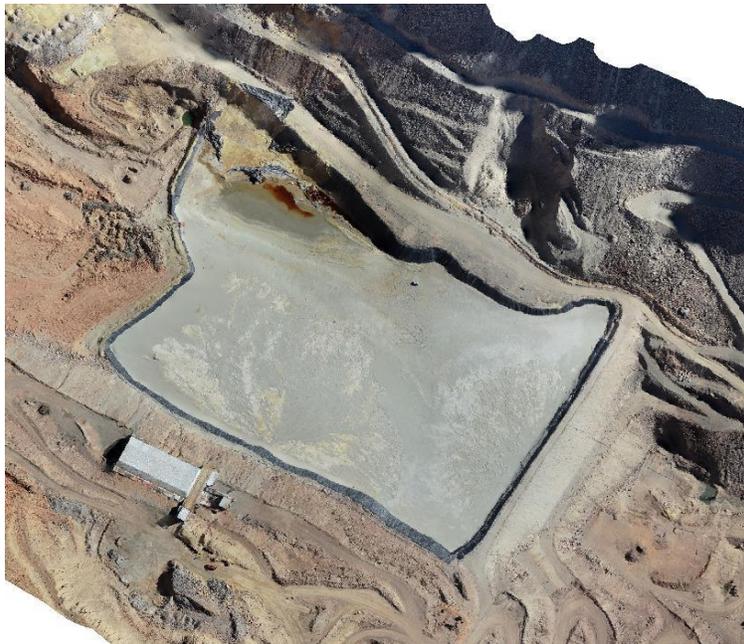
(Drone picture of the tailings pond, looking to the north)

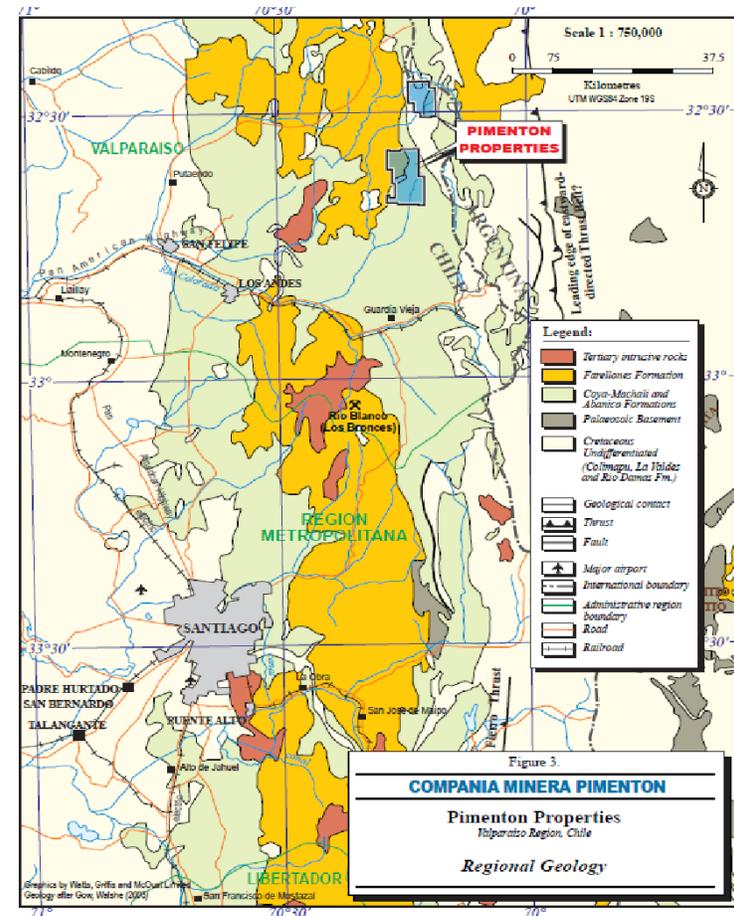
Figure 3. Regional geologic map (from Sernageomin).

The regional geological map shows a predominance of Upper Cretaceous to Lower Tertiary Abanico Formation (Figure 3). It consists mainly of andesitic volcanic rocks intercalated with continental sandstones and bedded tuffs. Its total thickness has been estimated to be 3,000 to 5,000 m. Unconformably overlying the Abanico Formation is Mid-Tertiary (Middle to Upper Miocene) Farellones Formation. These volcanic and sedimentary formations are intruded by porphyry stocks that vary in size, texture and diorite-type composition, and in the impact on the intruded formations.

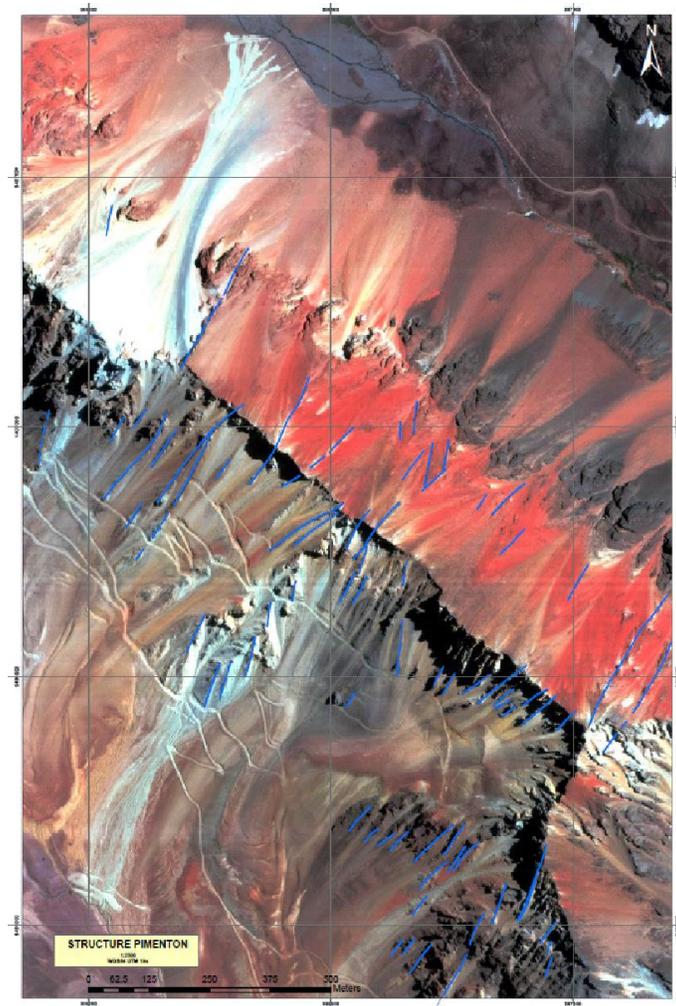
Figure 5. Inferred Veins and associated structures in Pimenton

Despite down-grading reliance on profitable mining of the Lucho vein system at depth, there is no certainty that other veins will be affected similarly. The recent discovery of two new veins – Monica and Kathy – and the work to date on developing them has been encouraging. Surface evidence of other veins, including some similar veins that have been mapped approximately 2.5 km farther north, are being re-evaluated by CEG together with geochemical and geophysical data. The structures as interpreted by CEG are depicted on Figure 5. The intention is to drill these targets when funds permit.

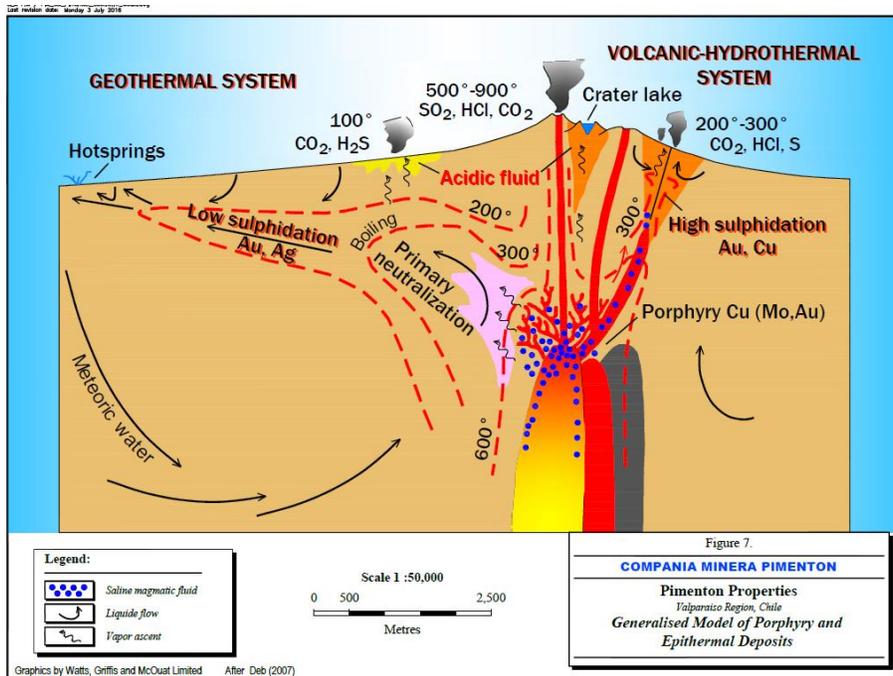
Figure 6. Generalized Model of Cu-Mo Porphyry and Epithermal Au-Ag deposits.

From several published models, WGM has chosen one (Figure 6) to illustrate the relationship of the high sulphidation epithermal vein system at Pimenton to a probable porphyry at depth. The model also illustrates lateral and vertical patterns that can be expected in the surrounding geology. Their presence at Pimenton is thought by WGM to be largely obliterated in the Pimenton valley by unrelated intrusions of diorite to diorite-porphry composition. The patterns are more likely to be present at depth and north and south of the mine and may exist to the east prior to being terminated by faulting suspected in the Colorado valley.

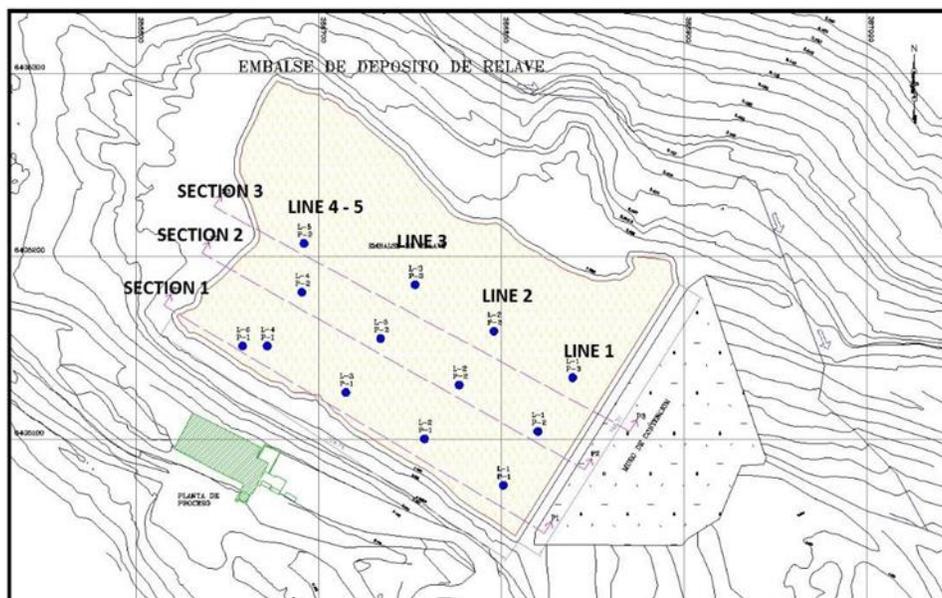
Figure 7. Tailings pond with wells drilled in sections and lines.

In 2021, the tailings pond was drilled with Auger-type wells to a maximum depth of 6 m. This sampling system is adequate until this depth and it is not recommended for deeper holes because of the higher water content in depth. A total of 13 wells were drilled, in 3 sections separated 35 m and in lines every 50 m as shown in figure 7.

In 2021, the tailings pond was tested by Tamidak with 13 Auger-type wells in a 50 m by 30 m grid until a depth of 6 m, with samples every 1 m. This sampling system is adequate until this depth but is not recommended for deeper holes because of the higher water content in depth.

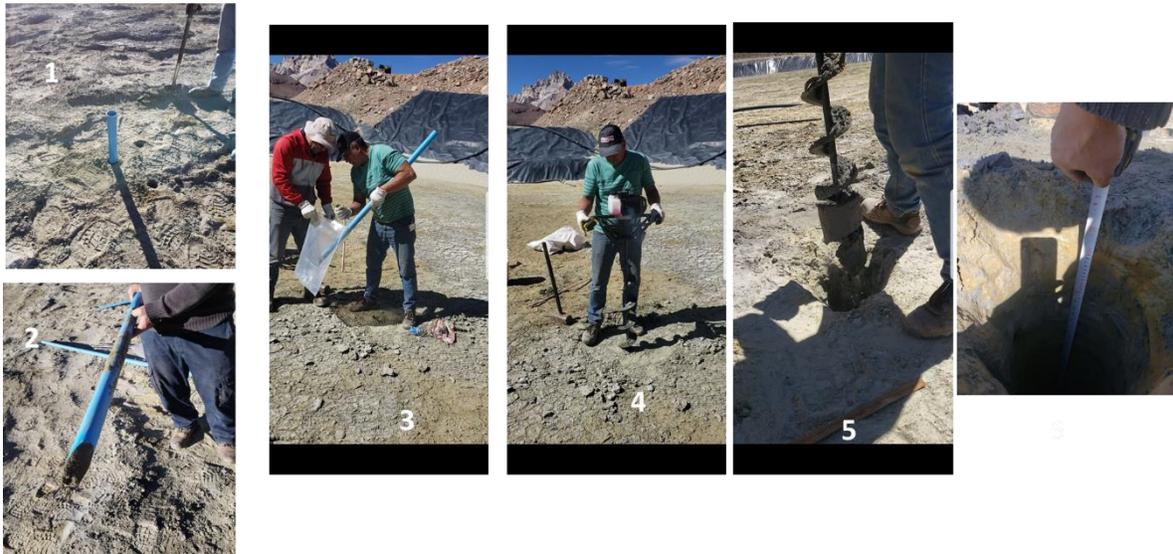
Figure 8. Sampling the tailing ponds at the Pimenton Mine by Tamidak personnel.

The data verification from the tailings sampling was completed by the author visiting the site and having a technician from Tamidak drill one hole to observe the quality of the drilling and the sample. The sample was collected, cleaned, free of impurities and contamination, being considered a representative sample (Figure 8).

The sampling was done in various steps, starting by inserting a 2 inches barrel until 50 cm extracting it with the sample placed in the bag (internal report in References). After cleaning the barrel, it was inserted for another 50 cm until 1 m with the sample placed in the same 1 m sample bag (picture 3). To insert the barrel, it was necessary to use a heavy hammer, especially at greater depths and an auger machine was used to drill until 1 m deep as is in pictures 4 and 5 of Figure 7. With respect to the hole drilled with the auger drill until 1 m, after cleaning the barrel, the 2 inches barrel was inserted first until 1.5 m and then until 2.0 m, taken so the second 1 to 2 m sample. The same process with the auger drill was repeated and completed until it was no longer possible to do so. In the Pimenton tailings pond, the maximum depth reached in this manner was 6 m.

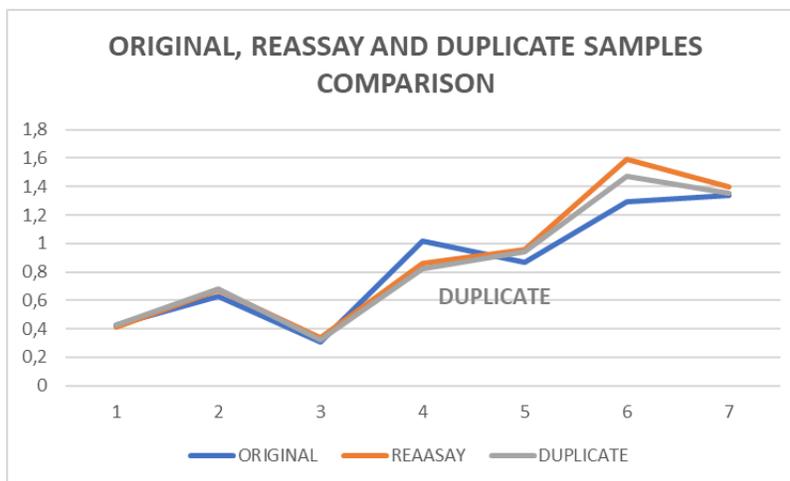
Figure 9. Comparison between original, re-assaying and duplicate samples.

Average of these different samples is 0.84 g/t Au for the originals, 0.89 g/t Au for the re-assaying of the pulp’s lab and 0.86 g/t Au for the duplicate. They are in an acceptable range of difference, with the original samples having a slightly lower grade. The following Figure 9 shows in a graphic, the comparison between original, re-assaying and duplicate samples:

The above chart lines show that the bigger differences seem to be only in 2 samples, but they are not of significance.

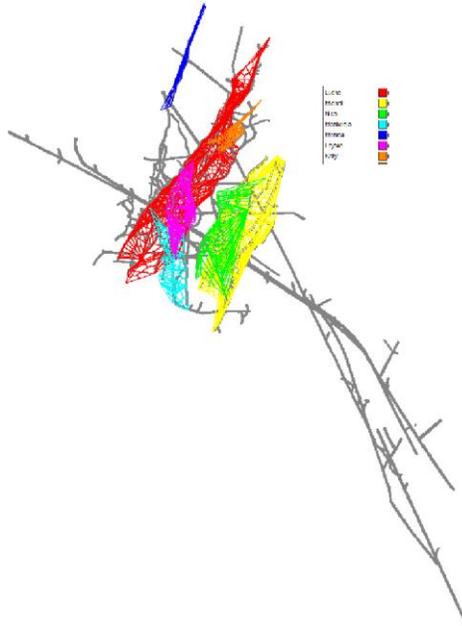
Figure 11: Schematic section showing some of the veins and the extraction adits in the Pimenton mine.

According to information provided by CEG, exploitation was done throughout extraction/transport using 10 adits built in different levels, in extensions until 800 m (being larger at lower altitudes) and with 270° azimuth. These adits cut the main exploited vein Lucho, Leyton and Michelle and, secondarily, the veins Nicole, Roxanne, Mannon, Kathy, Manterola, Canela, María Elena and Mónica. The adit altitudes are at 3,155, 3,195, 3,260, 3,315, 3,375, 3,430, 3,470, 3,510, 3,540 and 3,580 m a.s.l., meaning the veins have been exploited in around a 500 m vertical section (Figure 11). The veins are striking N30°E and inclined to the east, close to the vertical. Veins have in average around 30-50 cm width and the extraction labors have around 70-80 cm. The grade of the veins must support the dilution to be economic.

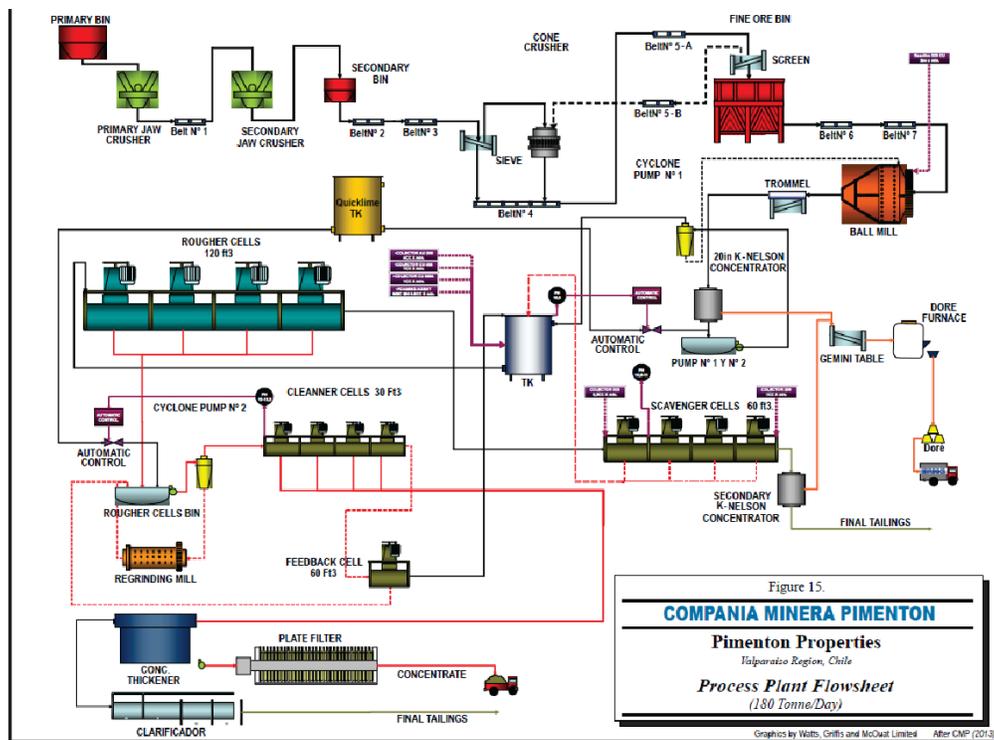
Figure 12: Process Plant Flowsheet

The process plant included the following steps (Figure 12):

- Crushing
- Milling
- K Nelson Concentration
- Flotation
- Filtering
- Tailing's deposition

The ore from the mine was transported by 25-ton trucks to the receiving hopper of the crushing plant; the ore was emptied directly into the hopper grate where, if necessary, any lumps that may exist were reduced to minus 6". Then, the mineral went through the following circuits: crushing, grinding, K-Nelson concentration, smelting and refining, flotation and

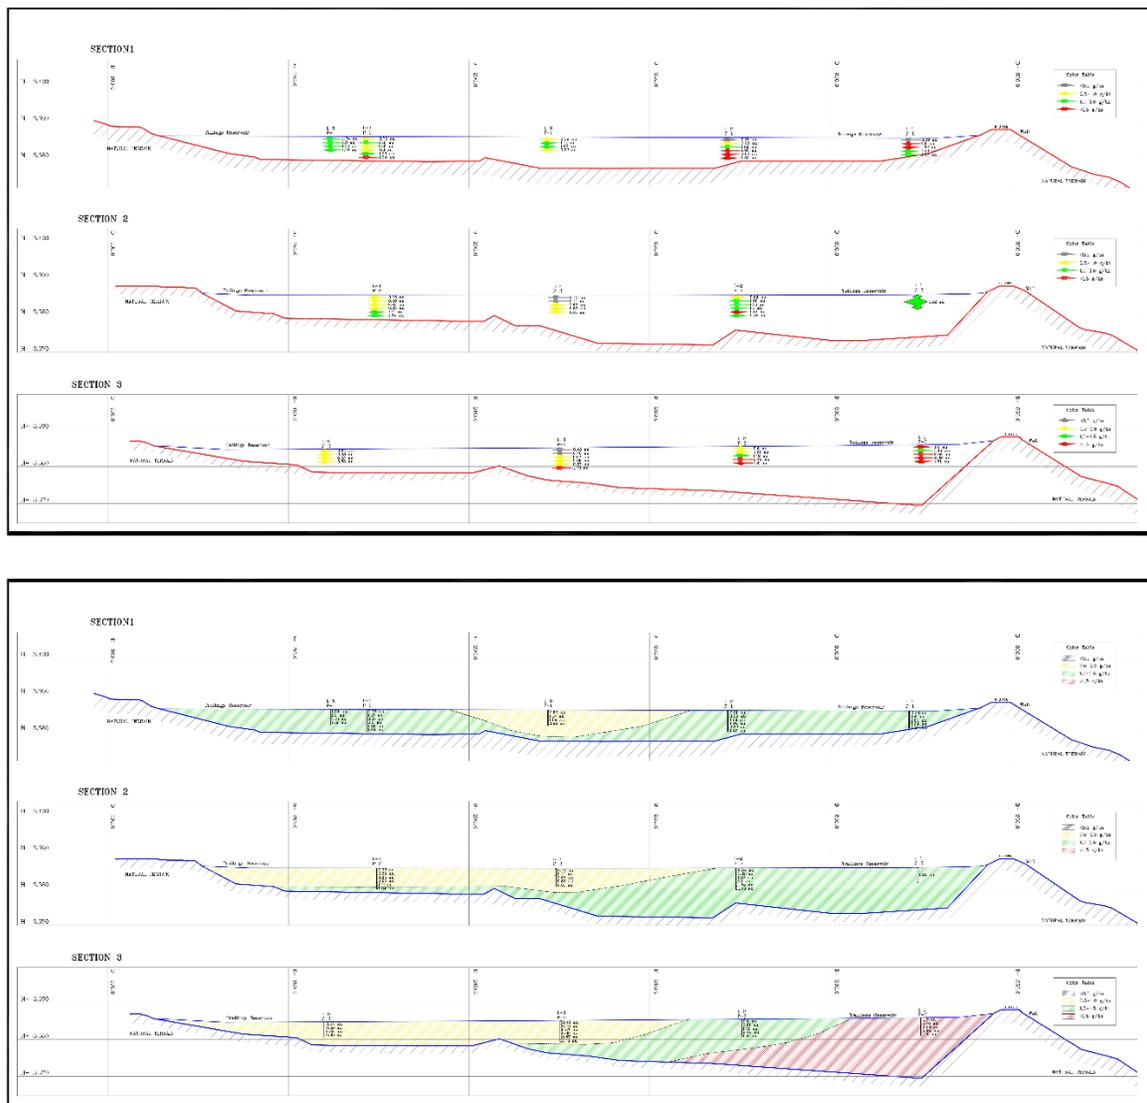
Figure 14. Gold in the Auger-type holes and the Gold distribution considering average gold grade in the holes (according to interpretation by the author).

Gold grades are showing an increasing trending through the lower altitudes, showing higher grades in the southeast sector of the pond. Also, higher grades are shown in depth, and it is suspected that even higher grades can be found closer to the bottom (Figures 14 and 15). Lower grades (lower than 1.0 g/t Au) are found in the upper sectors and especially in the northwestern section of the pond, close to the exit of the tailings from the plant.

As is described in this Technical Report under items 9 (Exploration) and 12 (Data Verification), average grade obtained from the Auger-type drill holes is 1.12 gpt Au. The grade distribution in the holes can be seen in Figure 13 and it is interpreted in Figures 14 and

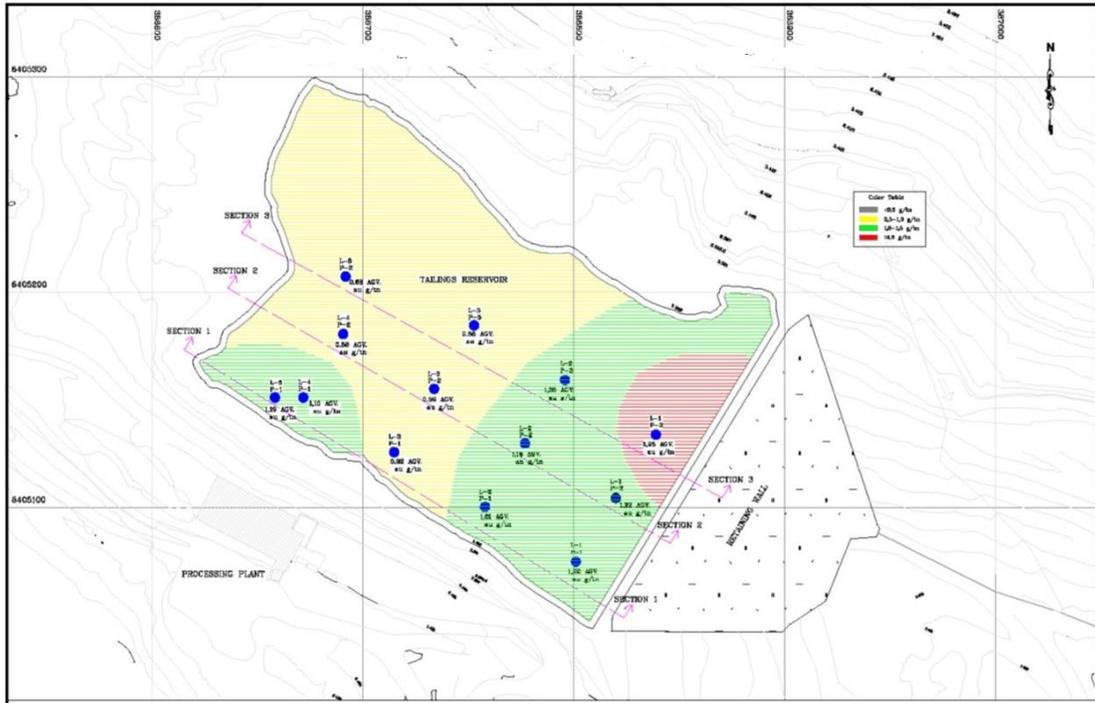
Figure 15. Average Gold grade distribution map according to average grades in Auger-type holes and at a “medium depth” in the pond.

This map and sections show that around a half of the eastern part of the pond has an average grade above 1.0 g/t Au (possibly in the order of 1.5 g/t Au), meaning that any new process operation should be initiated taking material from this eastern sector.
